DEPARTMENT OF TRANSPORTATION

Quality Assurance and Source Inspection

Contract #: 04-0120F4Cty: SF/ALA Rte: 80 PM: 13.2/13.9File #: 69.28**WELDING INSPECTION REPORT****Resident Engineer:**Siegenthaler, Peter**Address:** 333 Burma Road**City:** Oakland, CA 94607**Report No:** WIR-024687**Date Inspected:** 23-Jun-2011**Project Name:** SAS Superstructure**OSM Arrival Time:** 700**Prime Contractor:** American Bridge/Fluor Enterprises, a JV**OSM Departure Time:** 1900**Contractor:** Zhenhua Port Machinery Company, Ltd (ZPMC), Changxing Island **Location:** Shanghai, China**CWI Name:** Mr. An Qing Xiang**CWI Present:** Yes No**Inspected CWI report:** Yes No N/A**Rod Oven in Use:** Yes No N/A**Electrode to specification:** Yes No N/A**Weld Procedures Followed:** Yes No N/A**Qualified Welders:** Yes No N/A**Verified Joint Fit-up:** Yes No N/A**Approved Drawings:** Yes No N/A**Approved WPS:** Yes No N/A**Delayed / Cancelled:** Yes No N/A**Bridge No:** 34-0006**Component:** Orthotropic Box Girder(OBG)**Summary of Items Observed:**

OBG Assembly bay#14.

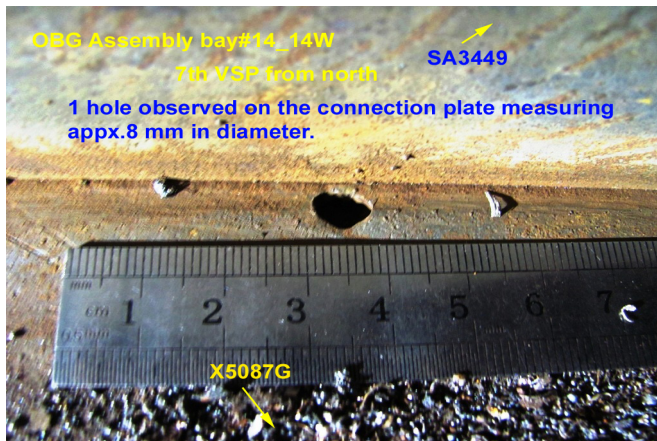
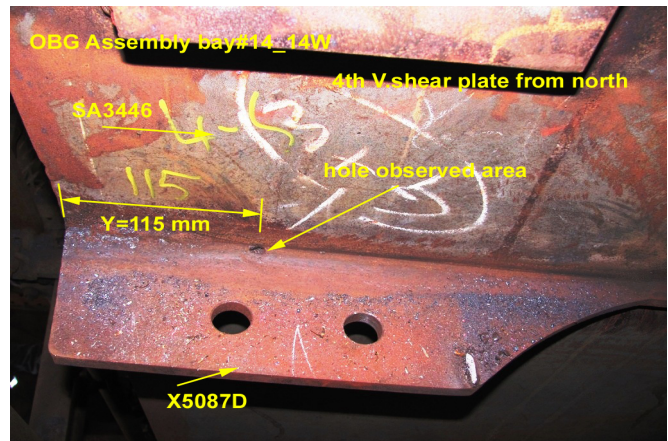
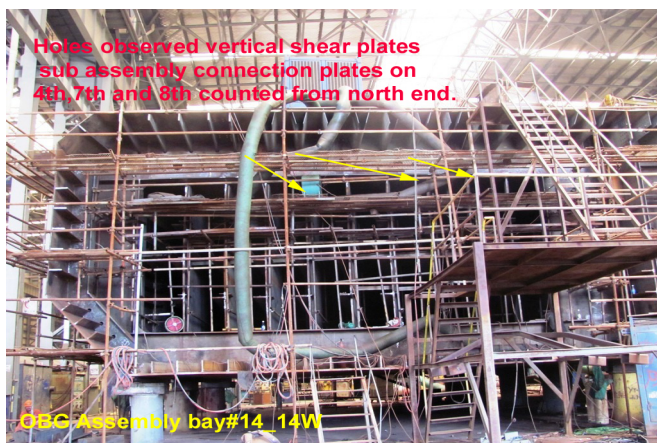
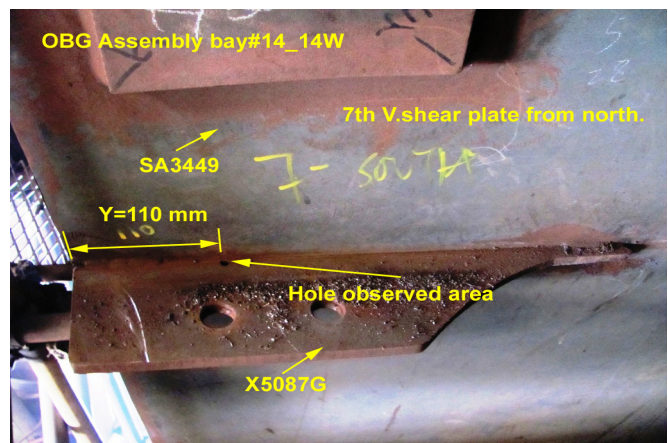
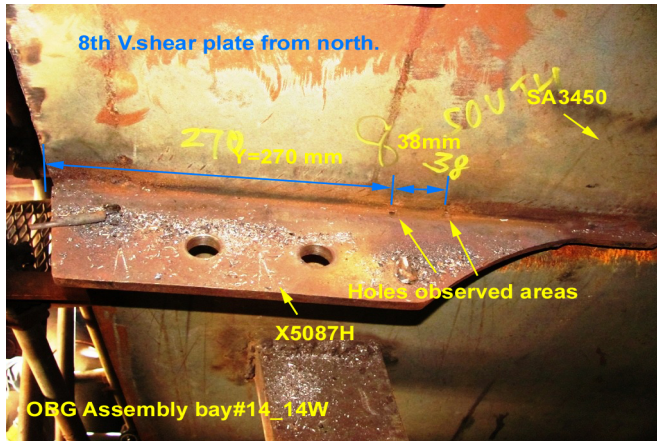
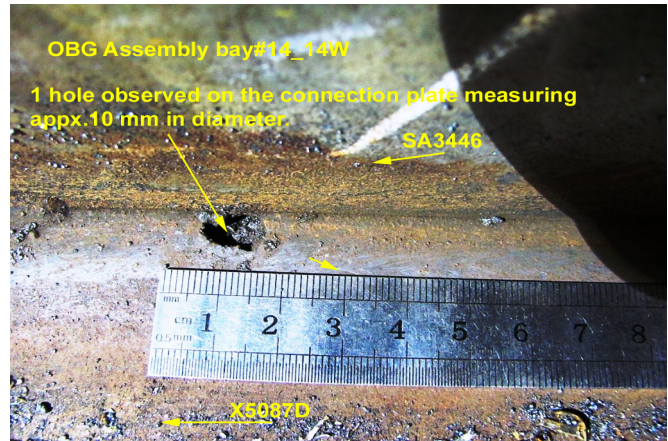
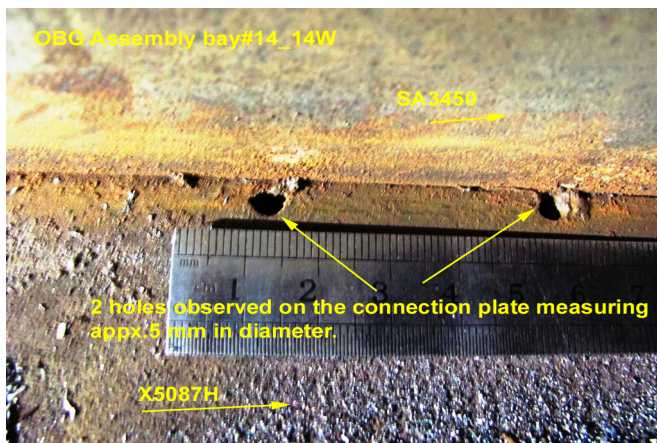
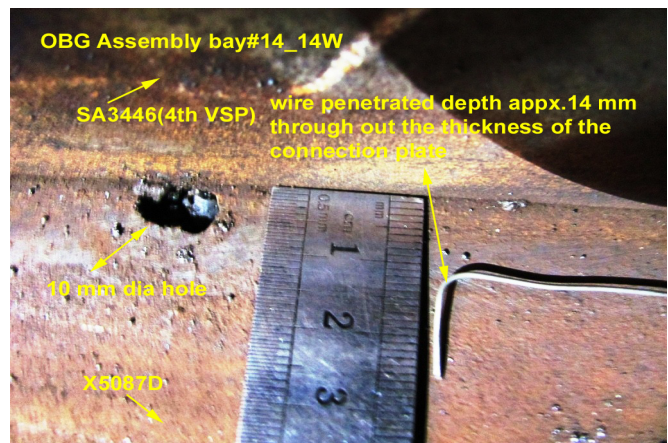
During random in process visual inspection of OBG sub assembly members identified as vertical shear plates SA3446,49 and 50, this QA observed 4 holes on the connection plates measuring approximately 5~10 mm in dia. The connection plate members are identified as X5087D, G and H respectively. The connection plates designated as Seismic Performance Critical Material (SPCM) on the approved shop drawing. The “Y” locations measured from the west side end of the connection plates as shown on the picture below. The thickness of the connection plates is 14 mm. This QA marked the affected areas and informed ZPMC Quality Control (QC) CWI indentified as Mr. An Qing Xiang and QC identified as Mr. Sun tian liang and Mr. Zhulin of this issue. These QC personnel informed this QA that the holes would be corrected in a manner compliant with the contract documents. This QA Inspector also informed to American Bridge/Fluor QA Inspector identified as Mr. Zhang Qili and CT Lead QA Inspector of the issue. See attached photos for further details.
